# Microsoft Band 2 Buttons Replacement

This guide will show you how to remove the side buttons on the Microsoft Band 2.

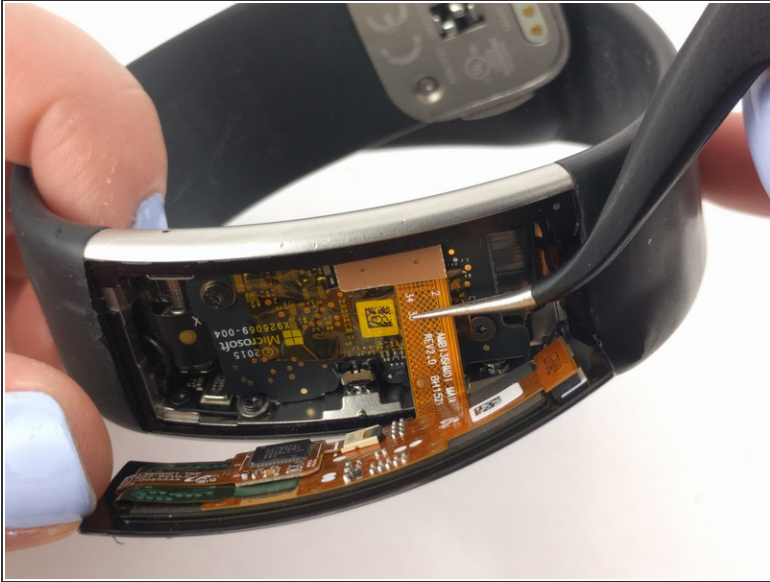
### Step 3

- Use metal tweezers to gently detach the orange press-fit (or "pop") connector.

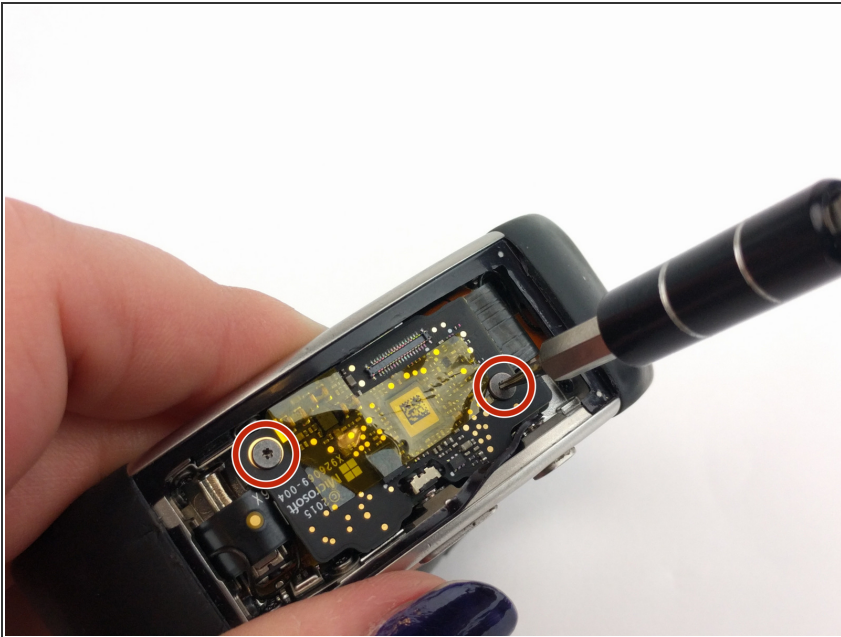
### Step 4 — Buttons

- Use the T3 Torx Screwdriver to remove the two 2.7 mm screws
